# CORD 810/812

**Section:** Engine and chassis

**Component:** Cap, radiator filler

Part number H10146

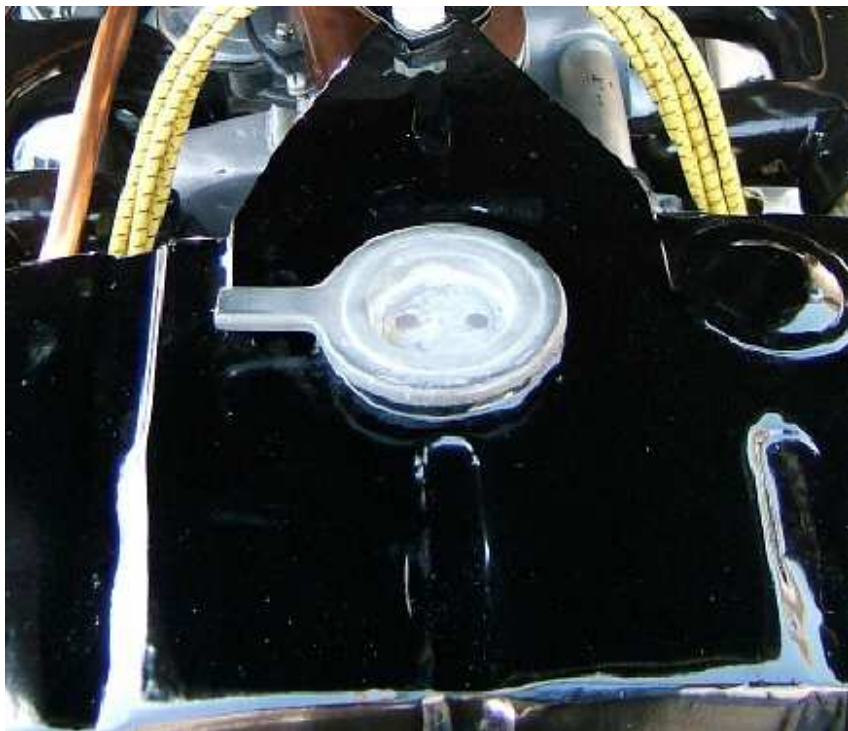
Cap has a single ear/lug/arm. The ear points toward the passenger side. (The original radiator had a brass ring in the neck of the radiator that stopped it in this position. When radiators were repaired in shops, that ring may have been changed.) Some experts state the ear points to the left or right depending on the way you start the cap when putting it on.

The plating of the cap was cadmium based on two NOS samples. Some caps may also have been zinc plated based on several experts' opinions. Zinc plating was available during the years of manufacture and may have been called "Utilite".
